# Plastic Design - Failure Analysis and Prevention

Paul J. Gramann, Ph.D., P.E.  
The Madison Group  
[www.madisongroup.com](http://www.madisongroup.com)

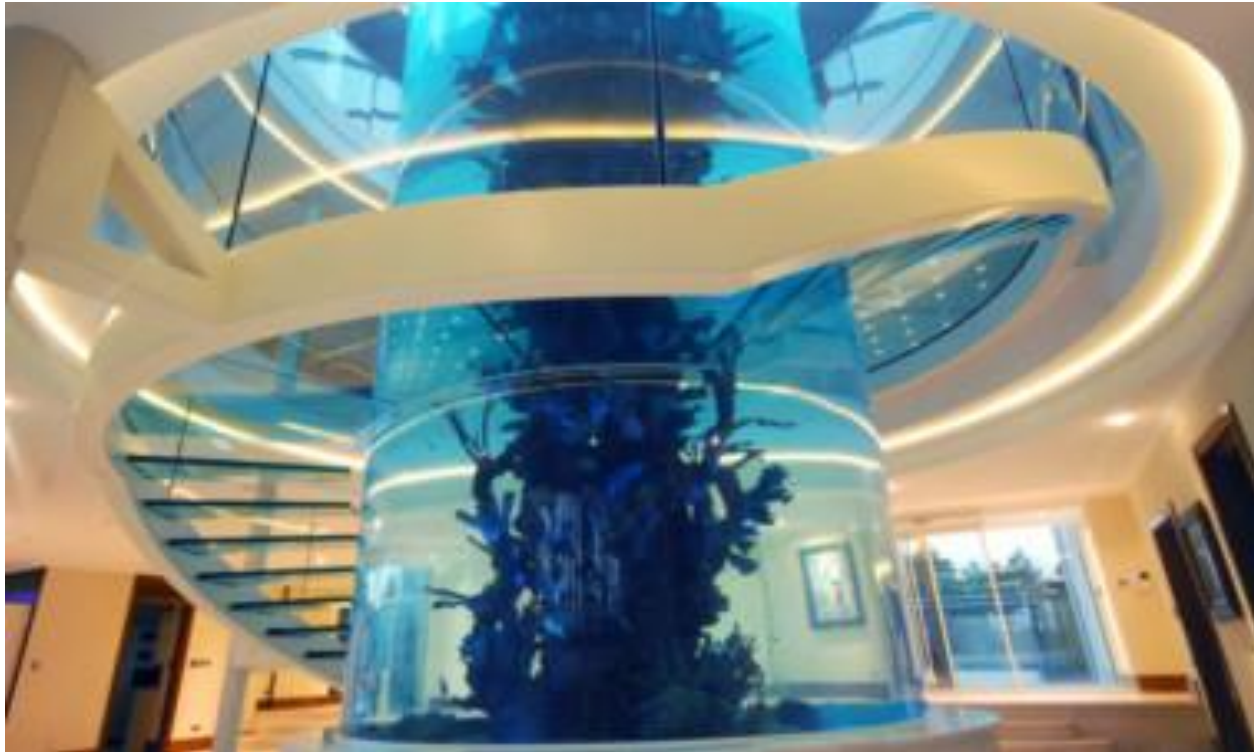
- Acrylic aquarium in Scotland failed ~3 years after being installed.
- Two vertical seams opened releasing all water and fish
- Catastrophic failure with over 200 large sections of acrylic
- Scanned each piece to digitally put back together
- Mapped every fracture surface to locate fracture origins - seams

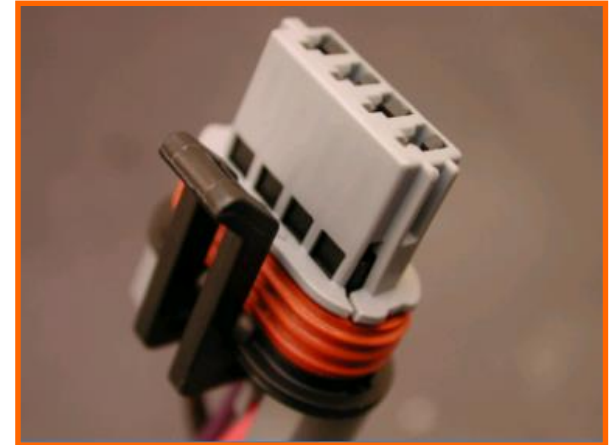
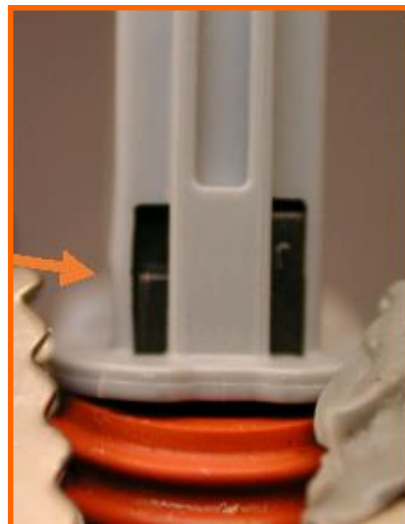
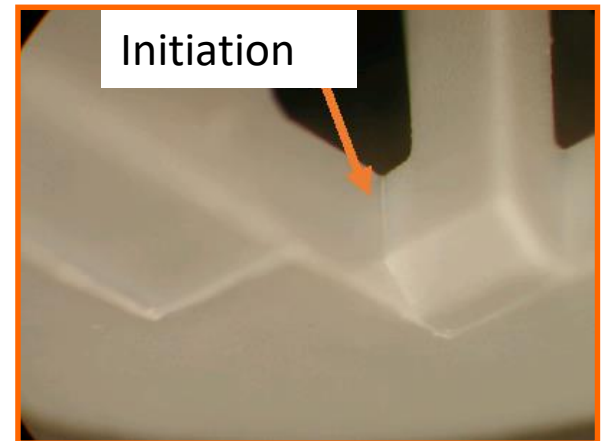
- Injection-Molded electrical connector
- Manufactured from unfilled poly(butylene terephthalate) PBT resin
- Snaps onto housing during service
- Part experienced consistent cracking several weeks after assembly

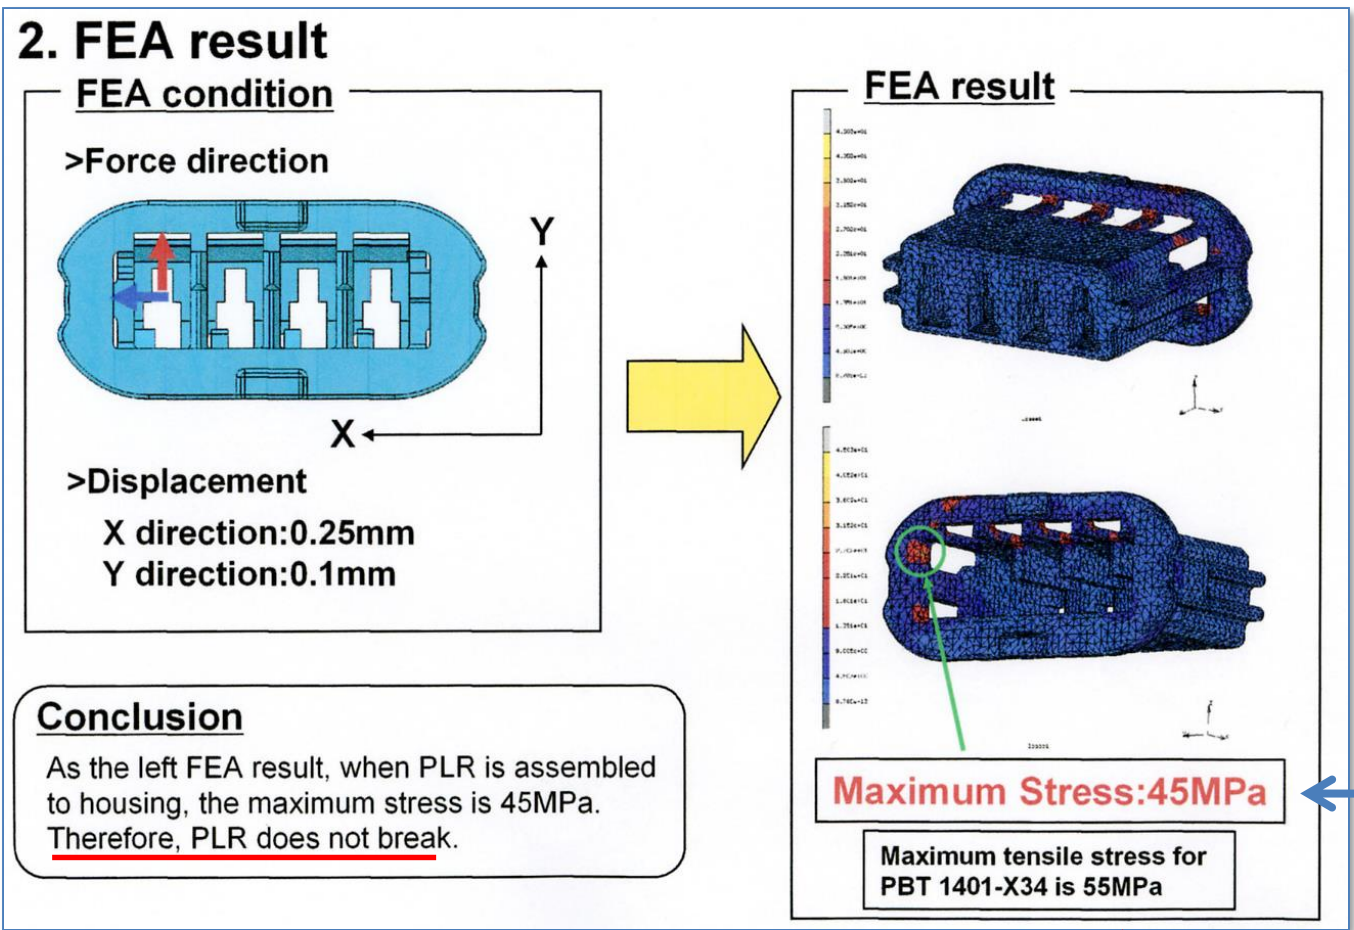
FEA Analysis of Manufacturer Confirming Part will NOT Break

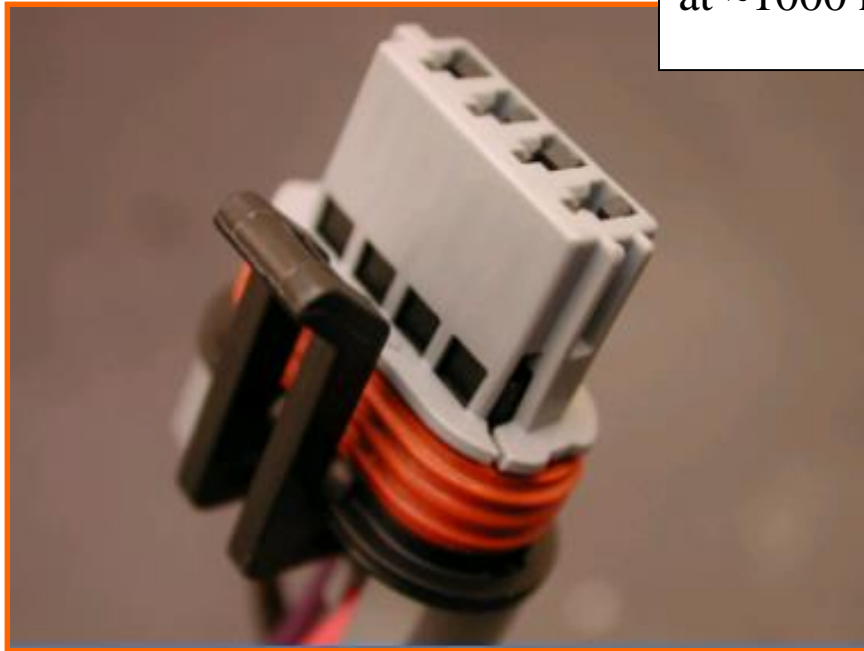
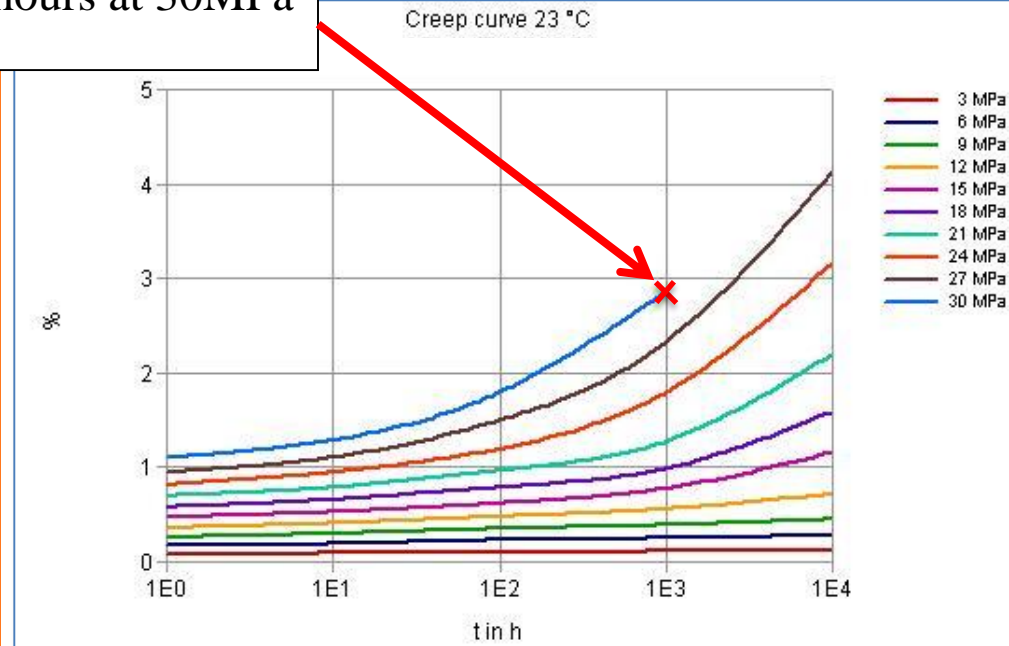
Using Data Available on the Web Predicts Failure

Part Predicted to Break  
at ~1000 hours at 30MPa

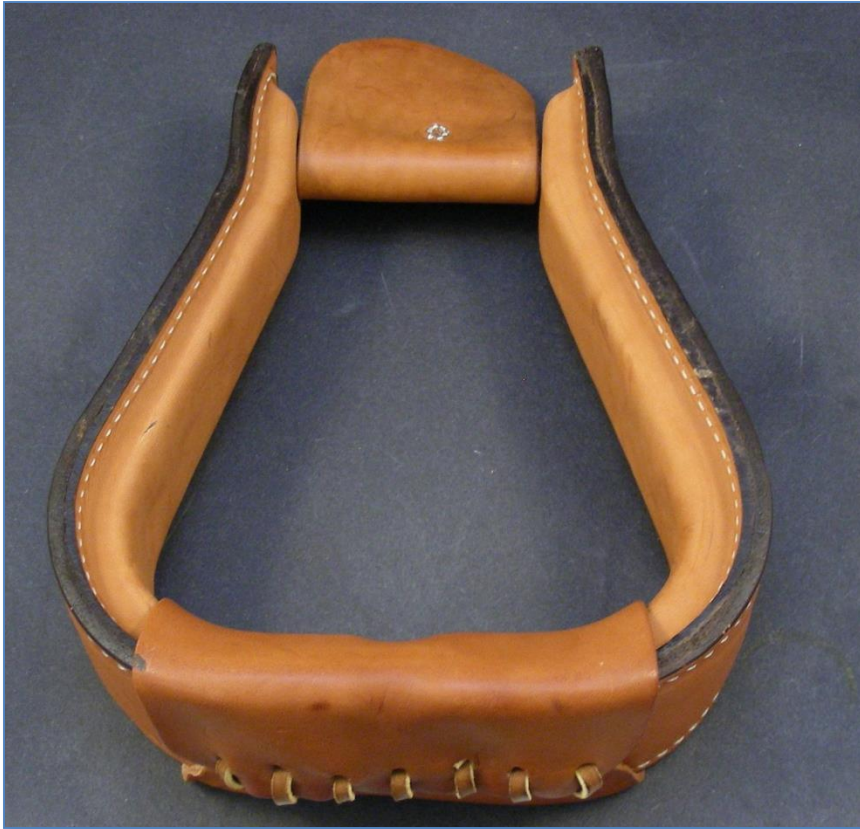
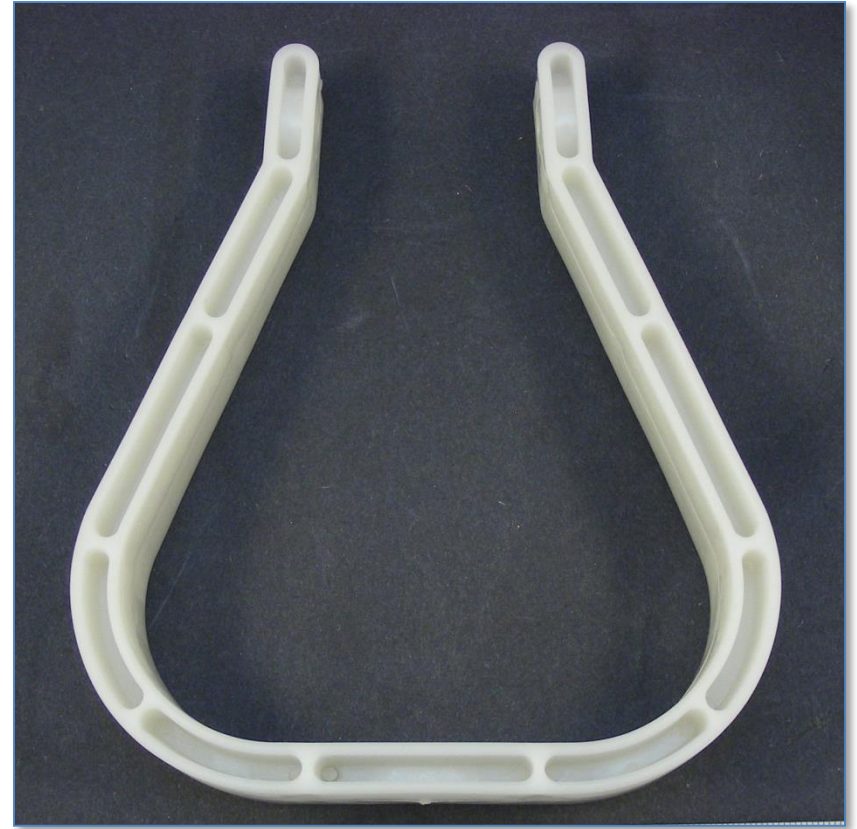
- Polyethylene Core - Made of Recycled Tyvec
- Failure Occurred at Staple Used to Hold Leather Covering to Plastic Core
- Resulted in Massive Injuries to the Rider

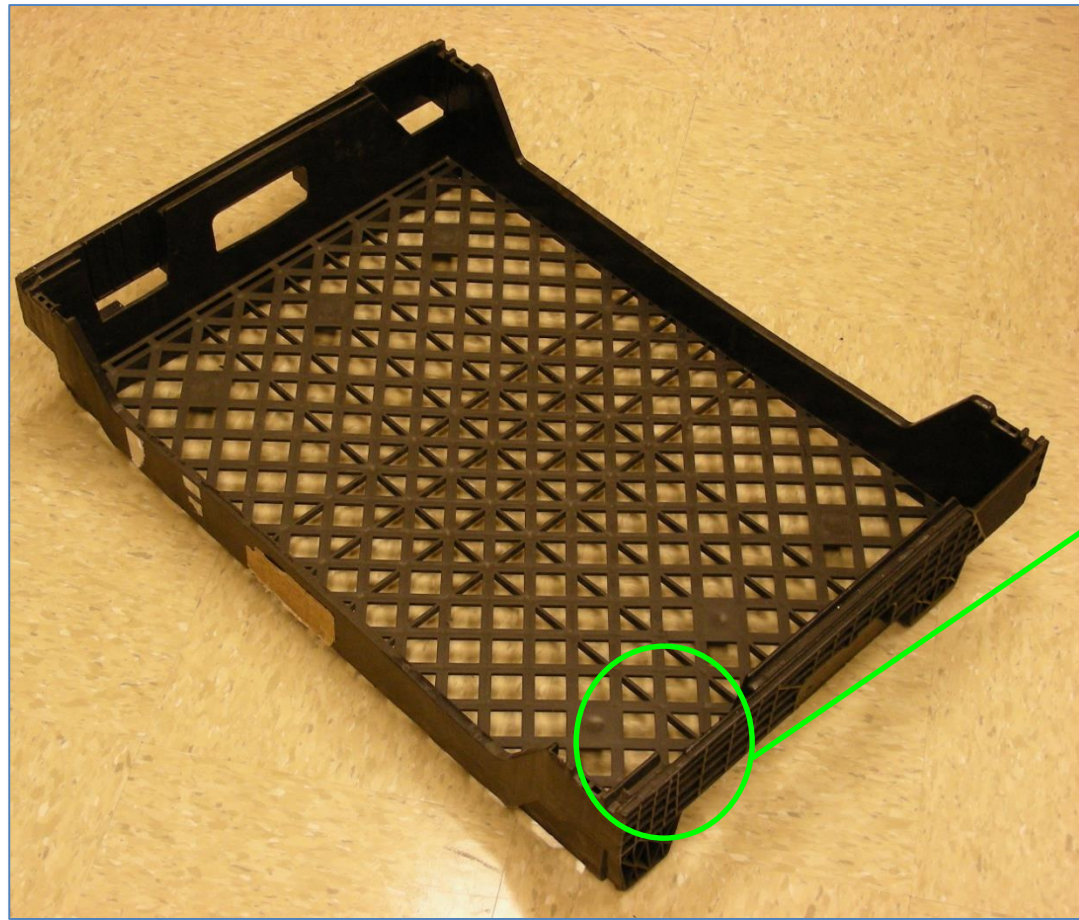
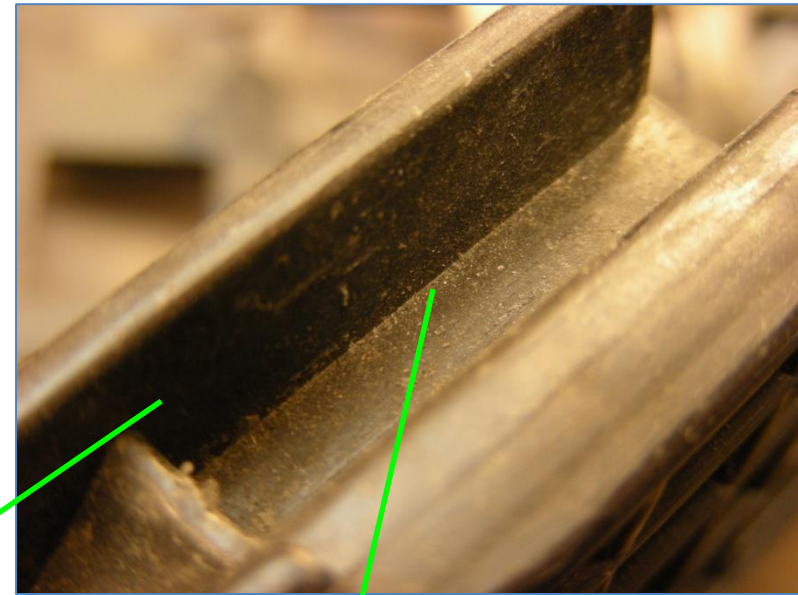
Sharp corner resulted failure of stacking rail and personal injury

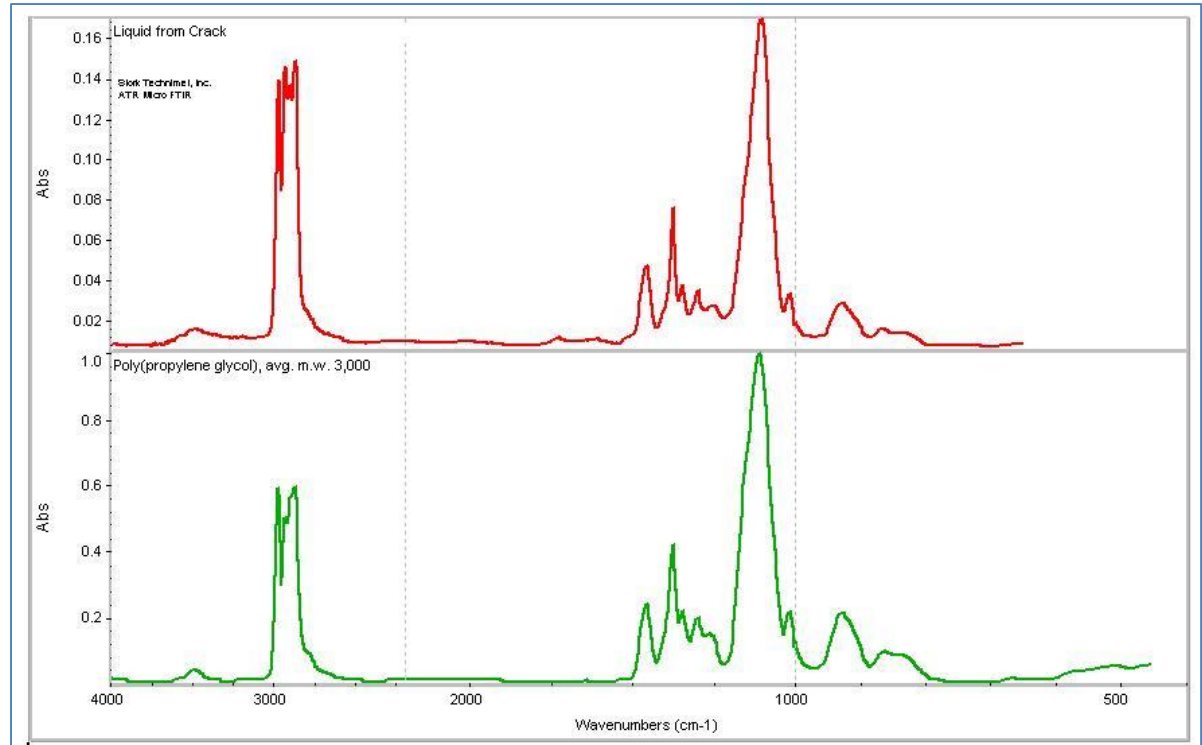
Infrared Spectrum (IR)  
on Oil Residue

Liquid at  
Crack

Polypropylene  
Glycol
